What's Wrong with using Ideal 65 and traditional twist-ons to repair aluminum wiring in residences?

"Independent Tests indicate Ideal-65 Twist-on retrofit connector fails UL 486C Safety Standard despite UL-listing"

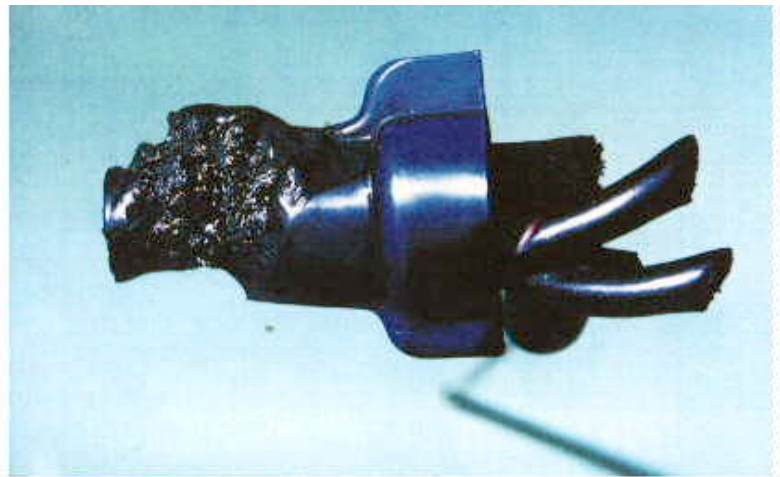
12. THIS FIELD FAILURE SHORTED TO GROUND when the thermoplastic insulating shell softened due to overheating in the connector spring area. Short circuits, due to insulation deterioration on the connector or wire, add to the fire hazard posed by the failure of aluminum-wired twist-on connections.

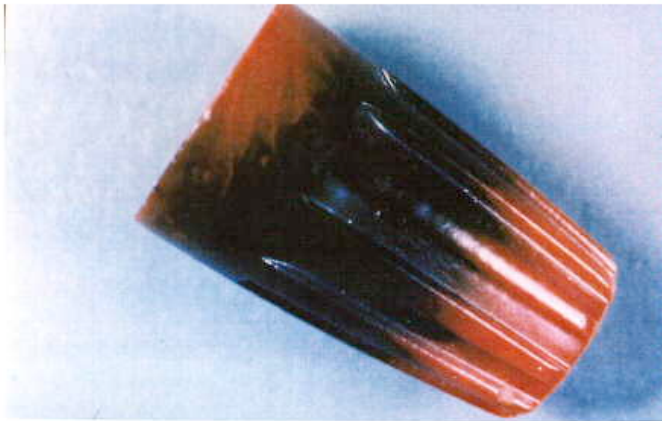
16. THIS LAST FIELD FAILURE AGAIN SHOWS THE TYPICAL OVERHEATING BAND. A number of field failures have been shown to emphasize that they are not rare. Both UL and CPSC investigated field performance and uncovered a substantial number of failures, with the worst-case failures resulting in structural fire and fatalities.

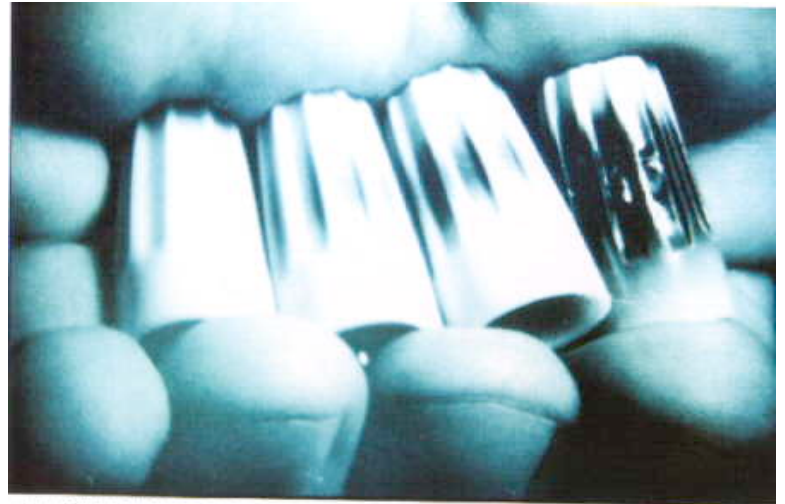
10. FIELD FAILURES ARE ALSO SEEN. These were from an aluminum-wired senior housing complex in the DC area. A large number of these twist-on connector splices were found with various degree of heat damage in an on-site inspection in which CPSC participated. (photo courtesy of Tom Donahue)

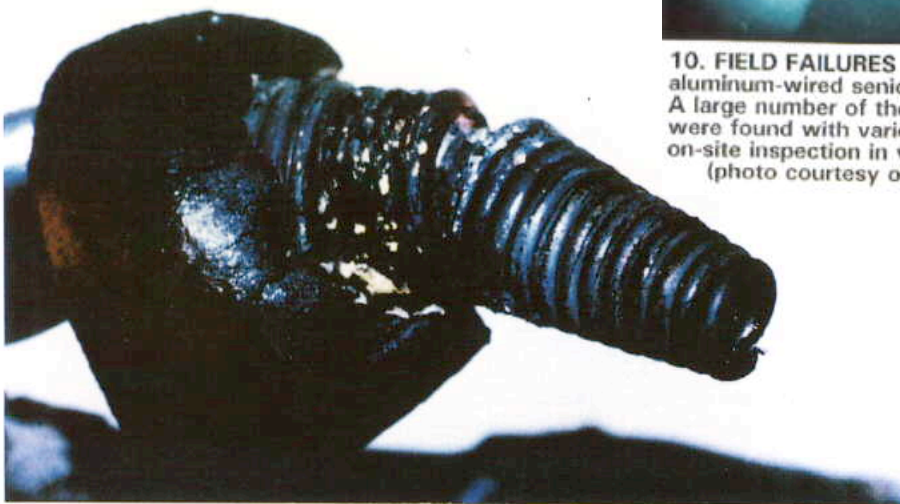
4. BURNOUTS LIKE THIS OCCURRED WHEN VARIOUS UL-LISTED TWIST-ON CONNECTORS WERE TESTED for the pigtailing application, installed as per the manufacturers' instructions. Poor test results for twist-on splices with aluminum wire were reported by UL, Battelle, CPSC, and various wire and device manufacturers.
